RARITAN RIVER BASIN  
LAWRENCE BROOK  
MIDDLESEX COUNTY  
NEW JERSEY

**WESTON MILLS  
POND DAM  
NJ 00164**

**PHASE 1 INSPECTION REPORT  
NATIONAL DAM SAFETY PROGRAM**

February, 1979

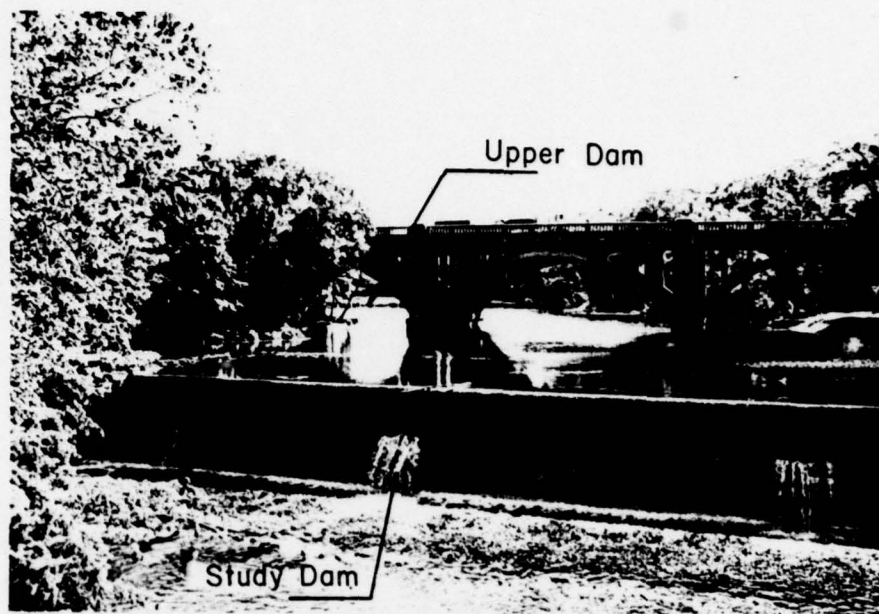
The masonry spillway is judged to be in a fair to moderately good condition, although one area near the left end of the spillway has bowed out downstream a few inches (see appended photographs) and settled a negligible amount. The concrete in the abutments is cracked and spalled but is in a fairly integral and serviceable condition.

Downstream view of dam

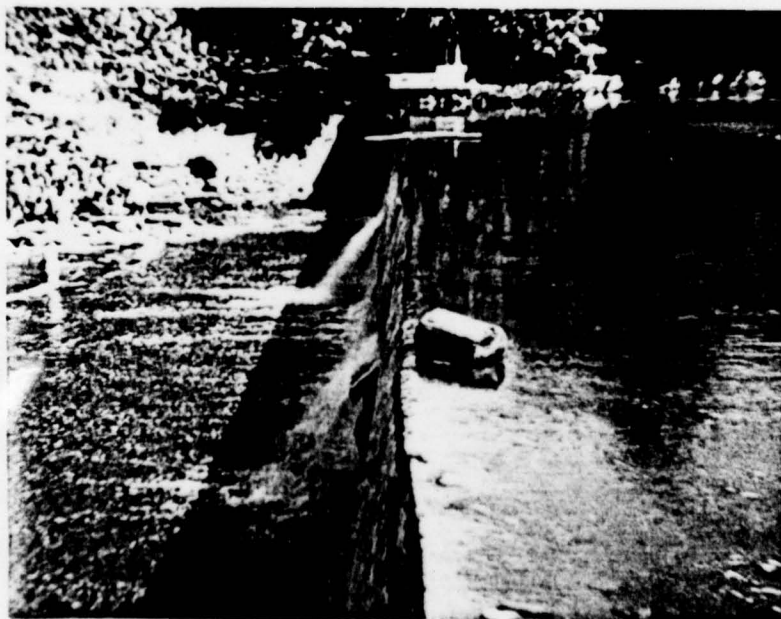
The top of the masonry spillway is in fairly true alignment and basically level within 1 or 2 inches. The capstones are 6" thick by 4'-6" wide (with a one-foot chamfer on the upstream side) and appear secure. Two masonry buttresses roughly 2 feet wide by 4 feet thick brace the wall on the downstream side. The exact thickness of the gravity structure and its depth below the downstream channel are unknown, but in view of its present alignment (after 90 years of storms) is fairly certain to be founded on the underlying New Brunswick shales. Early (circa 1917) records state that the structural height of the masonry wall is 22 feet and is stepped on the upstream face to a 12 feet width at the base. Except for the buttresses, the downstream face is vertical.

View of dam crest from west abutment

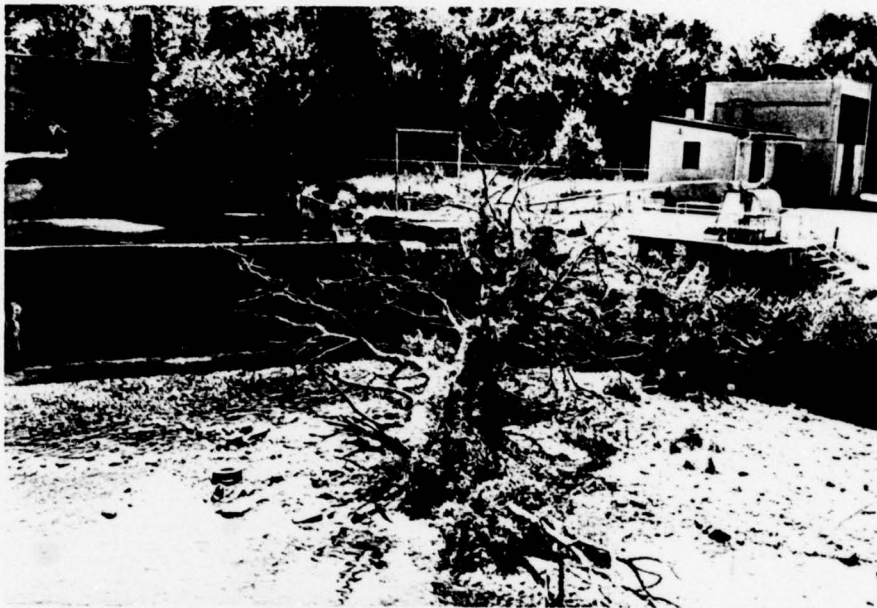
Some top-of-bank areas beyond the right spillway abutment show surficial erosion but this is of a minor nature. An old masonry wall extends downstream from the right abutment and connects to the flared wingwall of the Burnet Street bridge. Likewise, there is a low masonry wall extending downstream at the left spillway abutment. Although both walls are in poor

Downstream view of west abutment

b. Provide slope protection around the two spillway abutments.

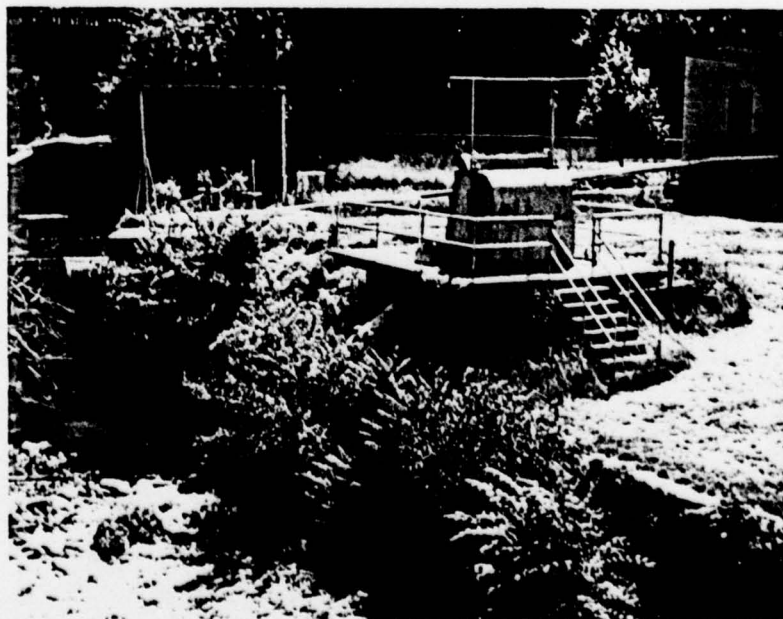
At the easterly end of the spillway, there are two 30" by 4'-6" sluice gates and at the westerly concrete intake structure a 30" intake line feeds the City water supply system. A trash screen is positioned diagonally across the northwest corner of the reservoir immediately above the water supply intake. Further to the left, there is an old, inoperative water supply gate which is no longer used. These structures are in moderately fair condition but numerous cracks and spalled areas were observed. The two sluice gates at the right abutment are operative, but have not been opened since 1975.

View of intake structure

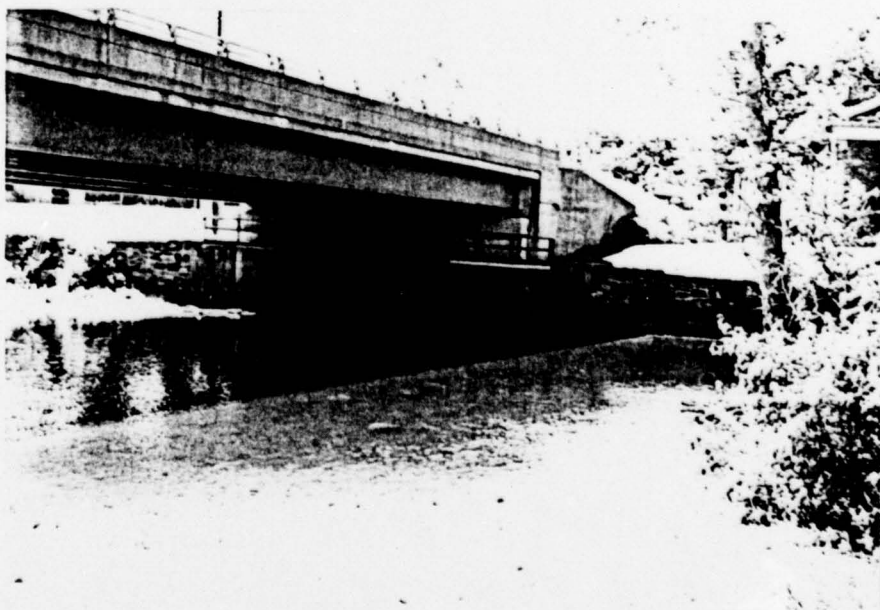
The downstream channel immediately below the dam is somewhat restricted by the Burnet Street bridge when periods of heavy rain coincide with maximum high tide. This bridge is approximately 104 feet downstream, has a span of 102 feet, a clear headroom in excess of 15 feet

Burnet Street bridge 104' downstream from dam
